# Manhole Inspection Summary

Manhole # S13II2006MH

**Location** Address: **2110 NORTHCLIFF DR**

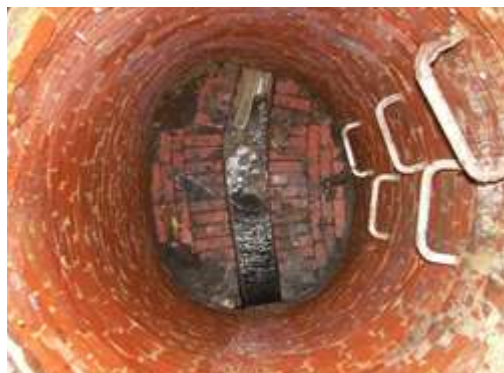
Top View

2nd visit. Evidence of surcharge - Bench debris. Channel debris.

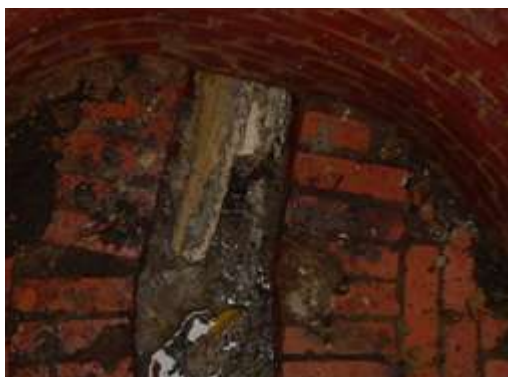
O12 pipe debris

Debris blocking outlet 50% - after cleaning.

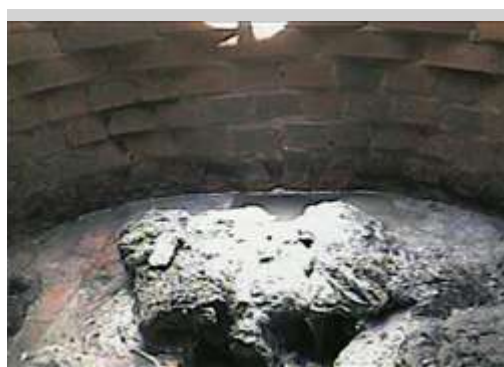
Defect

Bench and Channel debris - 1st visit.

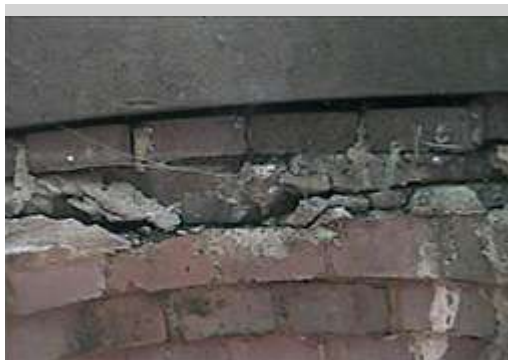
Defect

**Frame** Offset: **0** (in.) Condition: ☐ Sound ☐ Cracked ☒ **Leaks**

Condition: ☐ Sound ☐ Cracked ☐ Root Intrusion ☒ **Loose Brick** ☒ **Deteriorated**

Infiltration: ☐ None ☒ **Joint** ☐ Cracks ☒ **Mortar** ☐ Roots ☐ Wall

Frame leaks. Adjustment deterioration and infiltration.

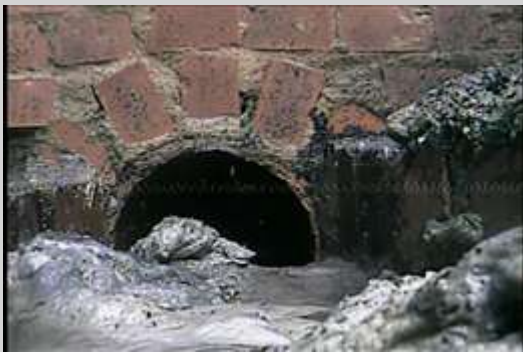
### 8 in. Circular Gravity Sewer Pipe Out @ 12 O'Clock

Deposits: ☐ None ☒ Mud ☒ Sludge ☒ Debris ☒ Grease

Silt Depth: **2** (in.) Deposits Extent: **Medium**

Infiltration: **Evidence** Pipe Seal Cond: **Unknown**

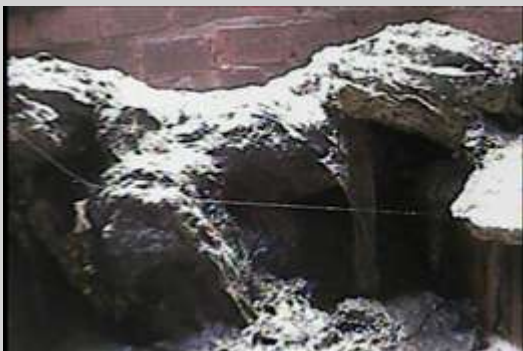
### 8 in. Circular Gravity Sewer Pipe In @ 6 O'Clock

1st visit pic.

Deposits: ☐ None ☐ Mud ☐ Sludge ☒ Debris ☐ Grease

Silt Depth: **3** (in.) Deposits Extent: **Medium**
